Solar Energy Implementation Case Study

Pork Chop Hill Farm LLC

By Jackie Thelen, Aryn Thomas, Heidi Vanderbeek, and Al Go
Michigan Farm Energy Program

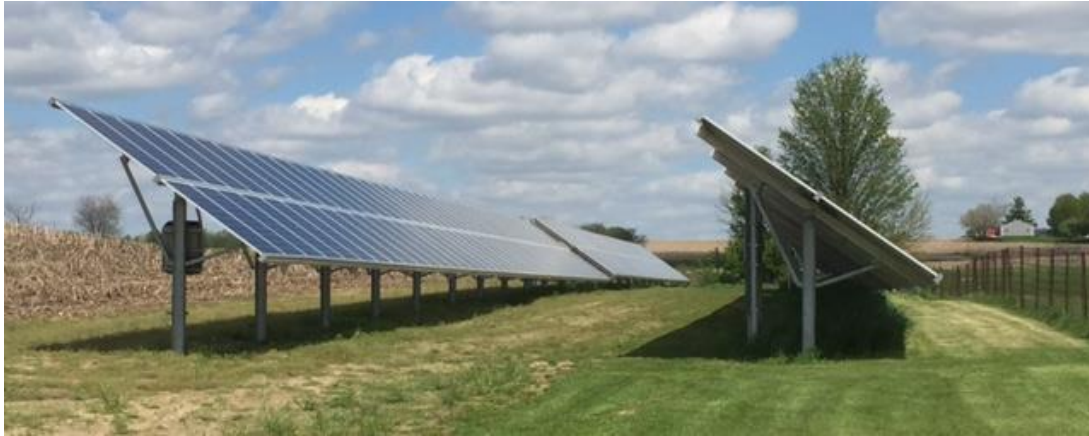
Figure 1 - The 75 kW solar energy system, positioned between a field and sheep pen.

Harvest Energy Solutions managed the material requirements, coordination with the electrical contractor and utility, and the final installation of the system. Harvest Energy also provided ideas for locations and orientations, but Tom and Margaret decided on the final location of the new arrays to best suit the needs of their operation. Starting on September 11, 2015 and lasting until September 22, 2015, the installation of the solar energy system went smoothly. The farm owners commented on the tidiness of the contractors, who cleaned up even the smallest pieces of debris after the installation. Since this unit was larger than the first system, the installation process lasted considerably longer than the first 19.76 kW system—11 days compared to 4 days. The system was connected to the energy grid by a separate electrician and commissioned by the utility. For the first month, however, the farm owners noticed that they were not receiving any energy credits for net electricity produced. Consumers Energy came out to examine the system and found that it had been wired to the grid incorrectly. After a few adjustments, the system was running perfectly, with no maintenance or electrical issues to date. The solar panels were positioned between a field and the sheep pen, out of the way but still close to the operations it was designed to power, so the installation did not inhibit the farm's typical processes. A picture of the completed system can be seen in Figure 1.

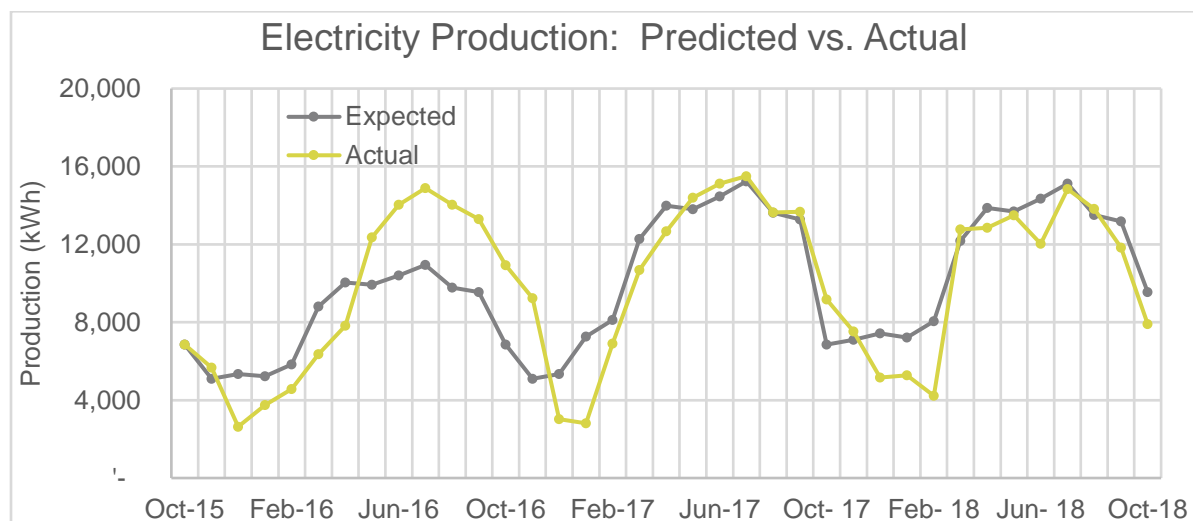
Figure 2 - Electricity produced by Pork Chop Hill’s solar energy system since implementation compared to predicted values provided by Harvest Energy Solutions

and electrical production of the system. The utility sends the owners a customized statement for the solar energy system on a monthly basis. Monthly data of actual and predicted electricity production is shown in Figure 2, and raw data is included in Attachment 2. Predicted values are based on Harvest Energy’s solar electricity production averages of previous years. The system produced less over the winter months than predicted, though this is not presumed to have a major effect on the overall annual performance of the system since the majority of energy is produced in the summer months. This deviation may have resulted from the above-normal cloud cover in Michigan due to the strong effects of El Niño, experienced between December 2015 and May 2016. See Attachment 3 for additional data showing the impacts of El Niño on cloud cover.

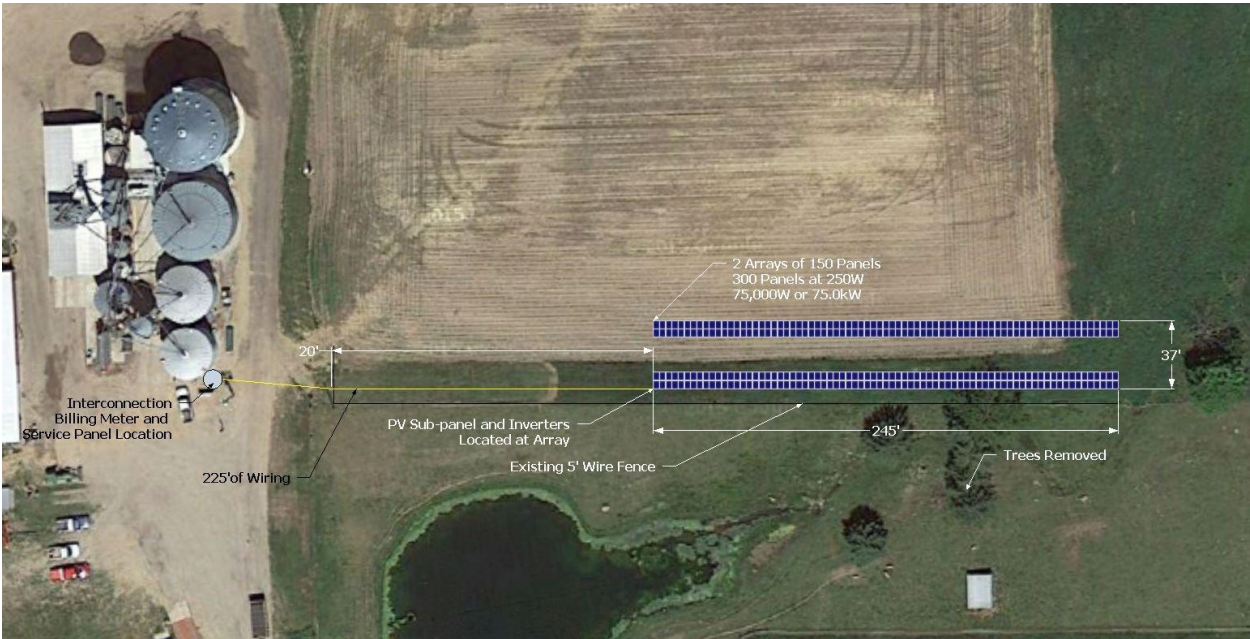
Attachment 1

Below is an aerial view of property with the original schematic of the solar arrays and electrical connections. This shows Pork Chop Hill's second solar energy project located between the field and sheep pen.

The second solar energy project implemented at Pork Chop Hill Farms was a fixed, ground-mounted solar array with a vibrated I-beam structure including 2 sub-arrays of 150 250 W modules each, for a total of 75 kW. The system was installed by Harvest Energy Solutions, implementing SolarWorld panels and Fronius inverters. The solar field was positioned between their field and sheep pen, with an overall footprint of 9,065 square feet (37 by 245 feet). The system was designed to offset 90% of annual energy usage for the farm's machine shop, feed mill, and grain dryer system. A full specification sheet of the solar energy system as well as an aerial view of the system and surrounding property can be viewed in Attachment 1.
