## Farm Energy Efficiency Case Study Zone 5 Perennials

By Jessica Mehall and Heidi Vanderbeek  
Michigan Farm Energy Program

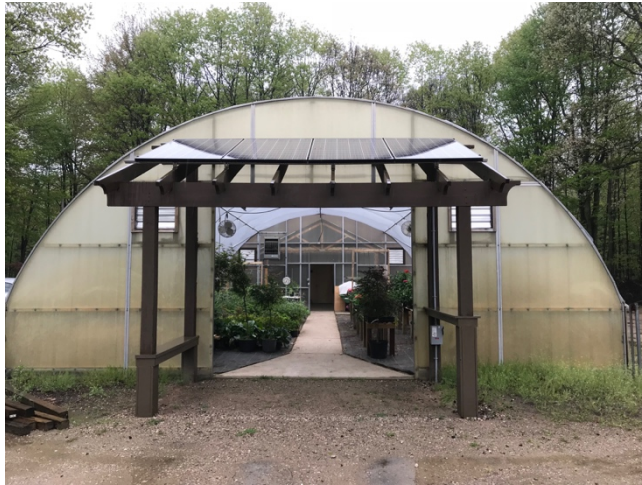
Pergola with three solar panels located at the end of the greenhouse.

Zone 5's property consists of a 50' long by 30' wide and roughly 12' tall green house with a small shop and store attached. The ECM project involved the implementation of three 160-watt solar panels on top of a pergola on the south end of the greenhouse. The total installation process took about one year. The owner decided to design and build the pergola that the solar panels currently sit on herself.

Originally, the owner's idea was to power fans with the solar panels, but the fans were very expensive. After consulting others, she decided to install a grid tie. The grid tie is able to run the fans, as well as pumps and lights. The three 160-watt panels charge a large battery bank and each solar panel is able to run independently, so if one panel does not get enough sunlight, the others are still capable of working.
